1974: DC10 Ermenonville

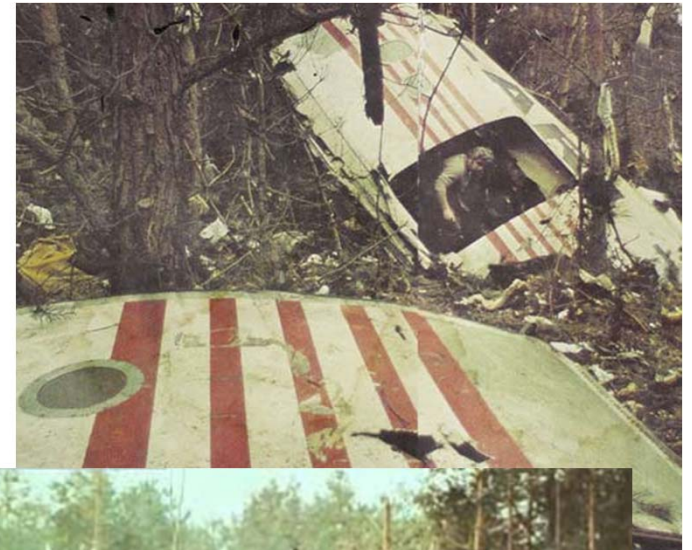
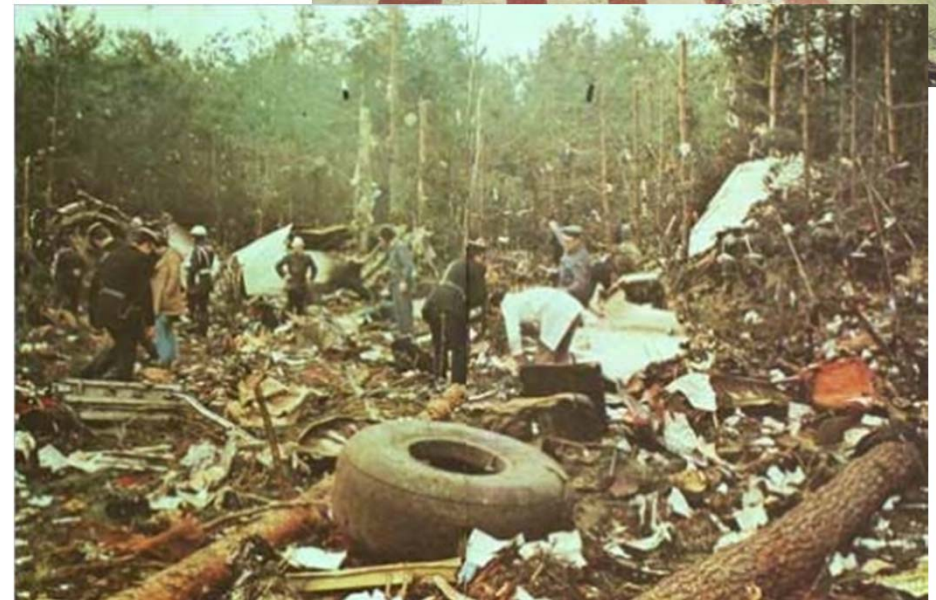
- Commercial flight Paris-London
- 334 passengers
- 12 crew members
- Daylight
- Good weather

- 11,000 feet during climb
- Sudden decompression

- Failure of the cabin floor
- Elevator and rudder cables were damaged
- Nose of the aircraft dropped to about 4 degrees
- The DC-10 ploughed into a forest at more than 500 kt disintegrating into a huge fireball.

- Cargo door locking system
 - ➔ Was badly manufactured since the beginning
 - ➔ But was known by McDonnell Douglas
- In 1972, a same event happened but crew managed to land the aircraft safely
 - ➔ Following these event, a gentleman agreement was made between McDonnell Douglas and the FAA in order to avoid an Airworthiness Directive
 - ➔ This agreement was allowing McDonnell Douglas to solve the problem at his own peace
- McDonnell Douglas had to pay huge compensations
- These events damaged the confidence about the DC10 that led the manufacturer slowly to bankruptcy.
