1978: DC8 Portland

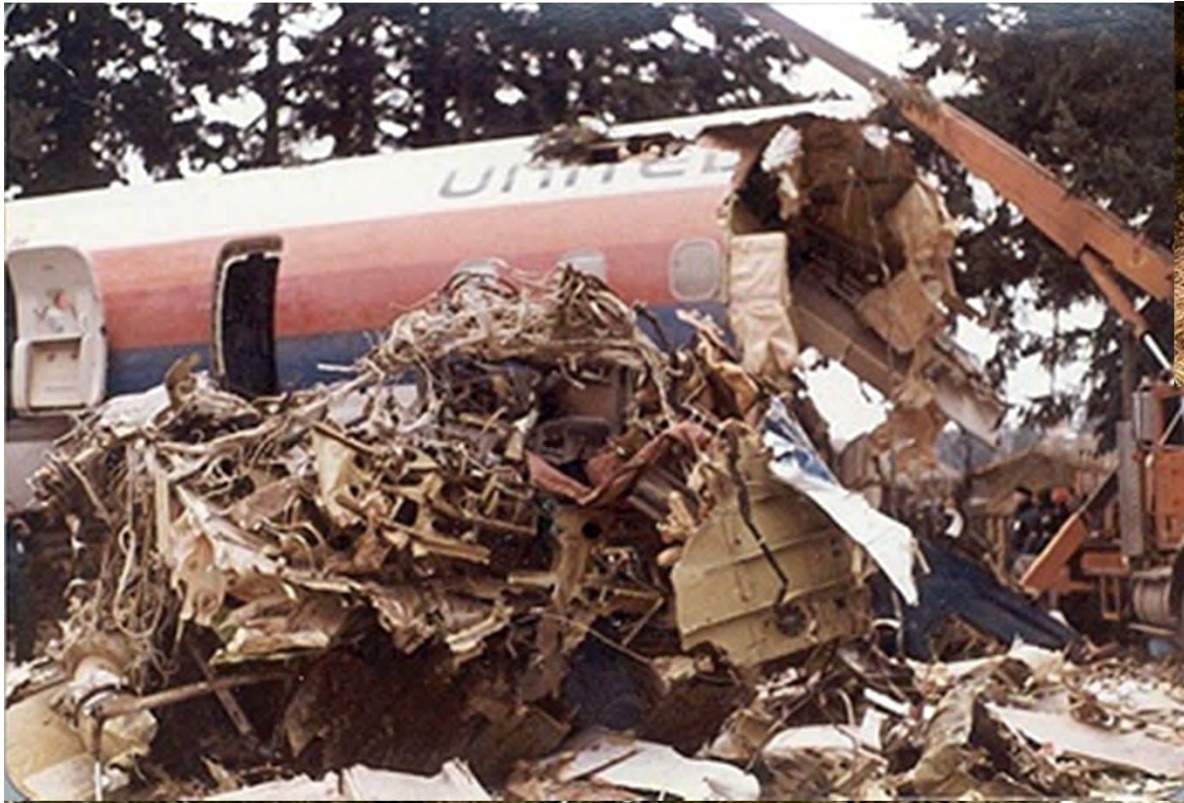
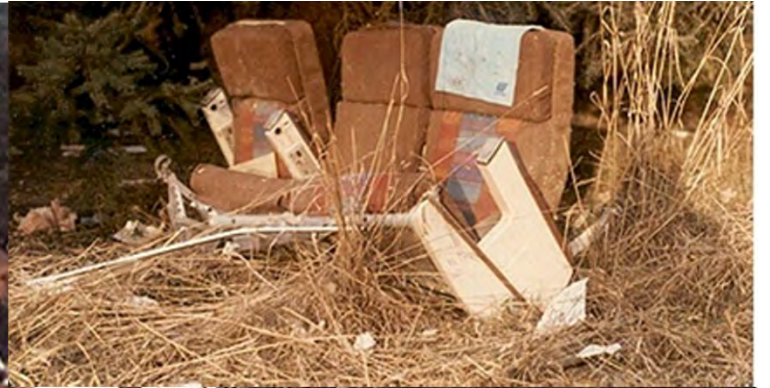
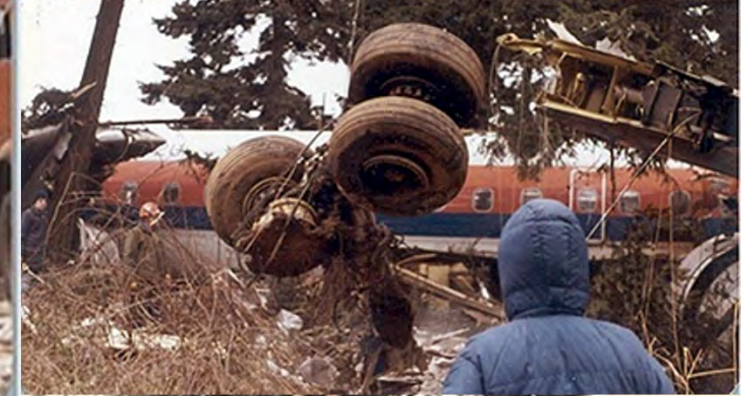
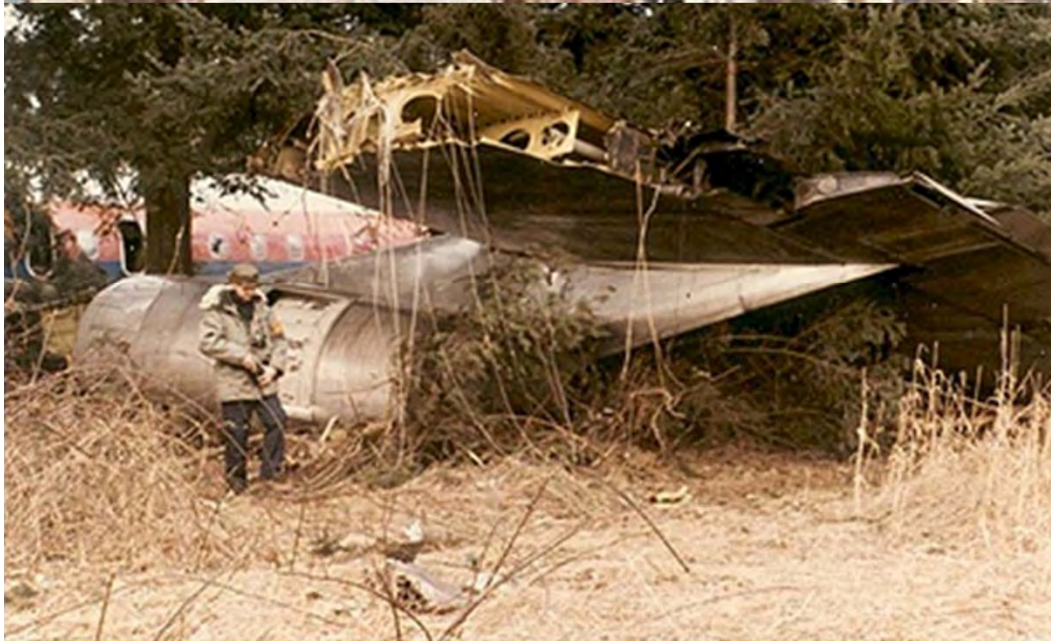
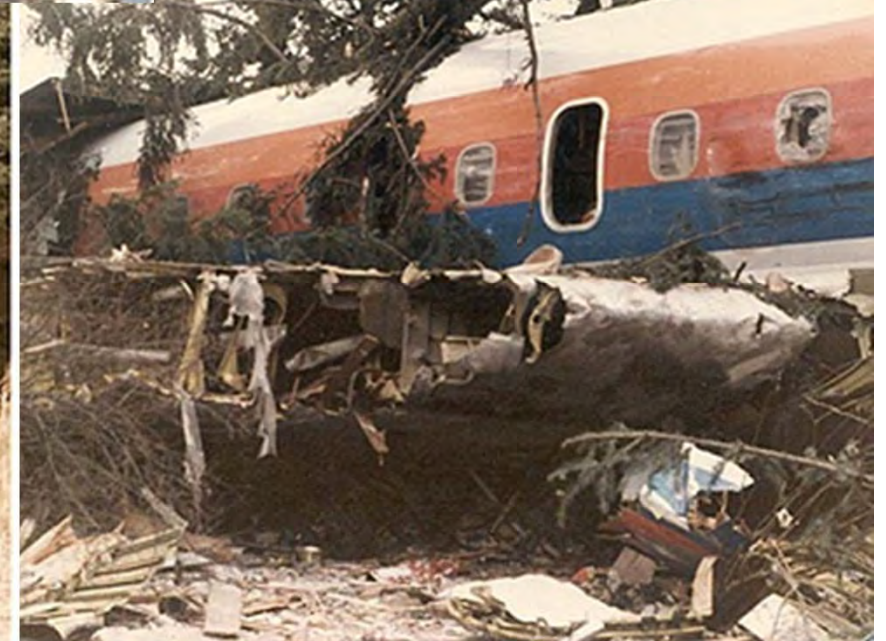
- Crashed into a wooded section of a populated area of suburban Portland
- 6 nm east southeast of the airport
- No fire (but...no fuel)
- Aircraft destroyed
- Of 181 pax: 10 killed, 23 injured
- Of 8 crew members: 2 killed, 2 injured
