#### 1999: 737-200 Buenos-Aires

- General context
  - Commercial flight taking off from Buenos Aires-Cordoba
  - 104 POB
  - Night
  - Clear sky
- Operational context
  - Take off
  - An alarm sounds...

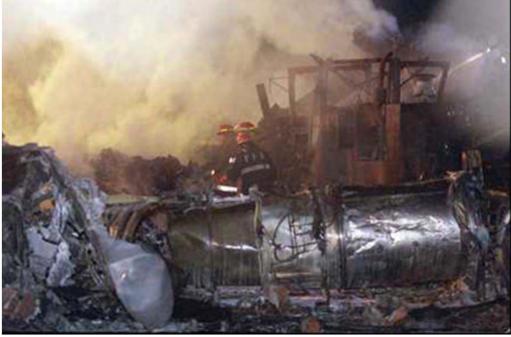
Airplane crushed through a fence, bounced across a busy highway, and skidded across a golf driving range exploding into flames.

- 79 killed
- Aircraft destroyed
- 3 cars crushed (1 killed)
