2002: Midair collision Uberlingen

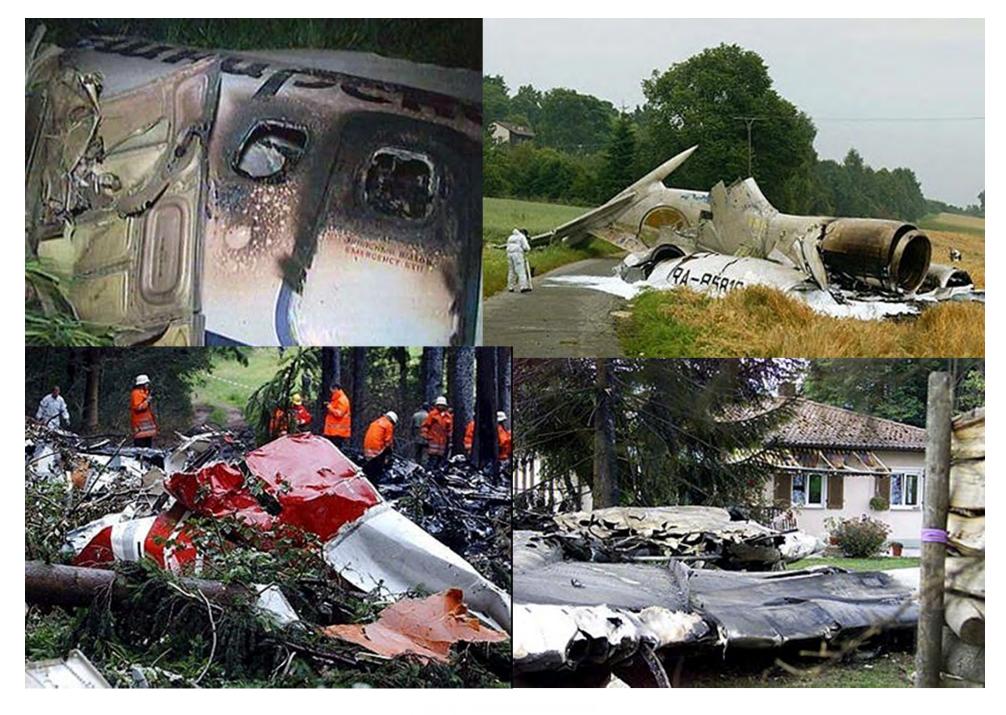
- All on board died from collision and crash:
 - → TU154M: 9 crew and 60 pax
 - ▶ B757: 2 crew
- Both aircraft were destroyed and debris scattered over an area nearly 40km wide.
- Some damage to fields and forests
- And... the ATC controller was murdered at his home a couple of days later by a relative of a deceased TU154M passenger...
