#### 1999: 737-200 Buenos-Aires

- General context
  - Commercial flight taking off from Buenos Aires-Cordoba
  - 104 POB
  - Night
  - Clear sky
- Operational context
  - Take off
  - An alarm sounds...

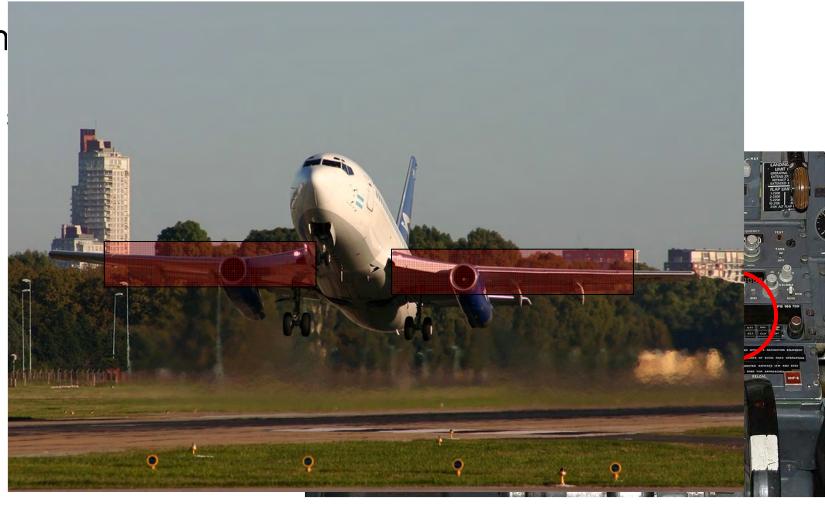
- Sound on the CVR recording:
  - TAKE-OFF CONFIGURATION WARNING HORN
  - For 37 seconds...
  - From the power up until... the crash
  - This warning horn was totally ignored by both crew
