2002: Midair collision Uberlingen

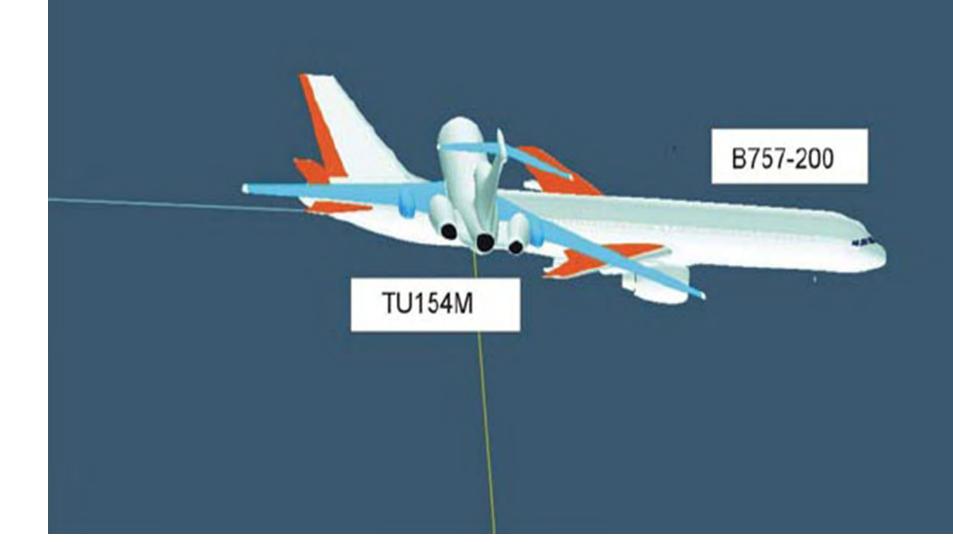
- General context
 - Both at FL360
 - Passenger TU154M Moscow-Barcelona
 - Cargo B757 Bergamo-Brussels
 - Dark night
- ATC context
 - ATC radar system was not fully functional
 - The optical STCA that would alert the controller 2.5 mn prior to impact
 - Failure of the telephone system

- About 50" before collision:
 - ATC instructed TU154M to descend to FL350
 - No response was heard from the Russian crew.
- Seconds later:
 - A second descent instruction was made
 - The Tupolev crew acknowledged the instruction
 - The TU154M TCAS issued a RA climb that was ignored
- At nearly the same time:
 - ◆ The B757 TCAS issued an RA descent
 - The crew began a descent in an attempt to avoid the conflict.
- The 2 aircrafts collided at FL354, broke apart and crashed.

- All on board died from collision and crash:
 - → TU154M: 9 crew and 60 pax
 - ▶ B757: 2 crew
- Both aircraft were destroyed and debris scattered over an area nearly 40km wide.
- Some damage to fields and forests
- And... the ATC controller was murdered at his home a couple of days later by a relative of a deceased TU154M passenger...
